Indoor air quality of museums and conservation of textiles art works. Case study: Salacea Museum House, Romania

Indoor air quality of museums and conservation of textiles art works.

Case study: Salacea Museum House, Romania

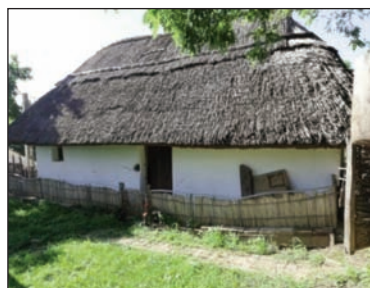
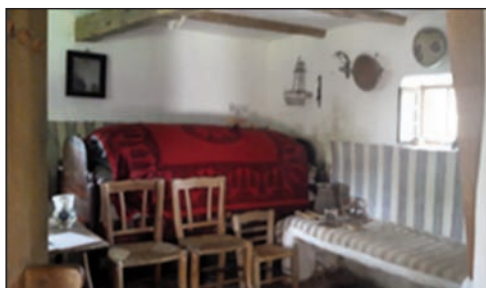
a

temperature, relative humidity and sunlight. These are destructive factors of textile fibers, especially natural textile fibers. These natural fibers found in the composition of the materials exhibited in the museum house (figure 2) have appropriate hygienic-functional properties under standard microclimate conditions (air temperature $20\text{ }^{\circ}\text{C} \pm 2\text{ }^{\circ}\text{C}$ and relative air humidity $65\% \pm 5\%$), the variation of these factors lead to the degradation of products made of natural fibers over time.

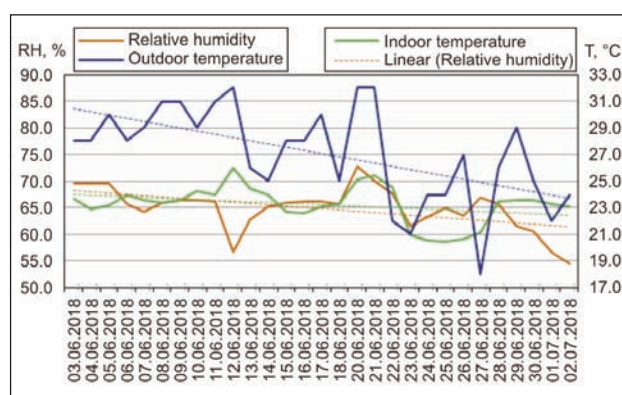
Fig. 3. Variation of air temperature and relative humidity inside and outside of Sălăcea Museum House, during the period 03.06.2018 – 02.07.2018

As a result of the air temperature and humidity analysis (figure 3) it was found that the average air temperature was $23.3\text{ }^{\circ}\text{C}$ and the average relative humidity was 65%. The temperature should not exceed $22\text{ }^{\circ}\text{C}$ (HG no. 1546/2003), always following its correlation with relative humidity (U.R.), and U.R. should generally be between 50% and 65%.

As a result of the results obtained during the analysis (average air temperature 23.3 °C; the mean value of relative humidity 65%, it was found that inside the museum house the two fundamental conditions necessary to ensure the optimal conditions of the microclimate are not fully met (air temperature 20 °C ± 2 °C and relative air humidity 65% ± 5%) in order to maintain the physico-mechanical and aesthetic properties of textile materials.
